Accident Reports.

20 November 1900

BoT Report into Accident at

Headfield Junction.

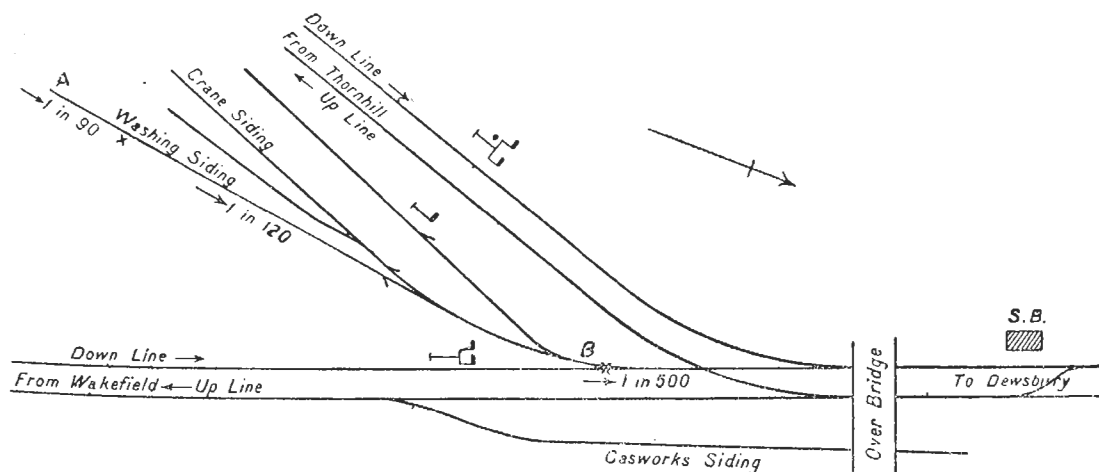
A. Position of truck when detached.  
B. Point of Collision.

In the angle formed by the down Wakefield to Dewsbury and up Thornhill to Dewsbury lines are some carriage and waggon repairing shops with several sidings, but all unite and have a common outlet in a single siding line with trailing points to the down Wakefield to Dewsbury line.

Thirty-six yards back from the fouling point of the single siding line and the down Wakefield to Dewsbury line these sidings have converged into three lines, and here are situated the three trap points to the sidings, all worked on the same lever in the signal cabin. Just behind these trap points is the outlet signal for the sidings, situated between the up Thornhill to Dewsbury line and the siding nearest to that up line.

Owing to a bridge situated only 30 yards to the south of the signal cabin, the fouling point of the siding line and the down Wakefield to Dewsbury line is not visible from the cabin, but the trap points can be seen.

block were very greasy, and no doubt the springing of the buffers which had been compressed when the engine set back on to the nine waggons just gave the single truck sufficient impetus to move slowly down the siding, when the engine and nine trucks started away from it. The truck was standing when detached on a falling gradient of 1 in 90, and 12 yards nearer the outlet siding the gradient changes to 1 in 120 to close by the fouling point, where it becomes 1 in 500. The distance the truck ran was just under 150 yards.

A minute or so later the passenger train ran into the truck, the engine striking it a glancing blow and knocking it clear of the down Wakefield-Dewsbury line on to the up Thornhill to Dewsbury line adjoining.

In view, however, of the fact that the fouling point of the sidings and main line is not visible from the signal cabin, the Company should, I consider, give instructions that after shunting operations of any kind, the signalman should always receive a message from the shunter or person in charge that everything is secure in the sidings and that the running lines are clear, before lowering his signals for the main lines, in order that Rule 62 (b) of the General Rule Book may be strictly carried out.
