# PLATFORM ONE

THE JOURNAL  
OF THE  
**Lancashire & Yorkshire  
Railway Society**

THE BLACKBURN COLLISION . . . . .	1
HUDDERSFIELD STATION . . . . .	3
UNUSUAL L. & Y. SIGNALLING . . . . .	4
LOCO PORTRAIT The 2-4-0 Tanks . . . . .	7
BOLTON STATION . . . . .	9
HALIFAX STATION . . . . .	10
LOCOMOTIVE LETTERING . . . . .	12
HEADS & TAILS . . . . .	14
CARRIAGE WARMING ENGINES . . . . .	19

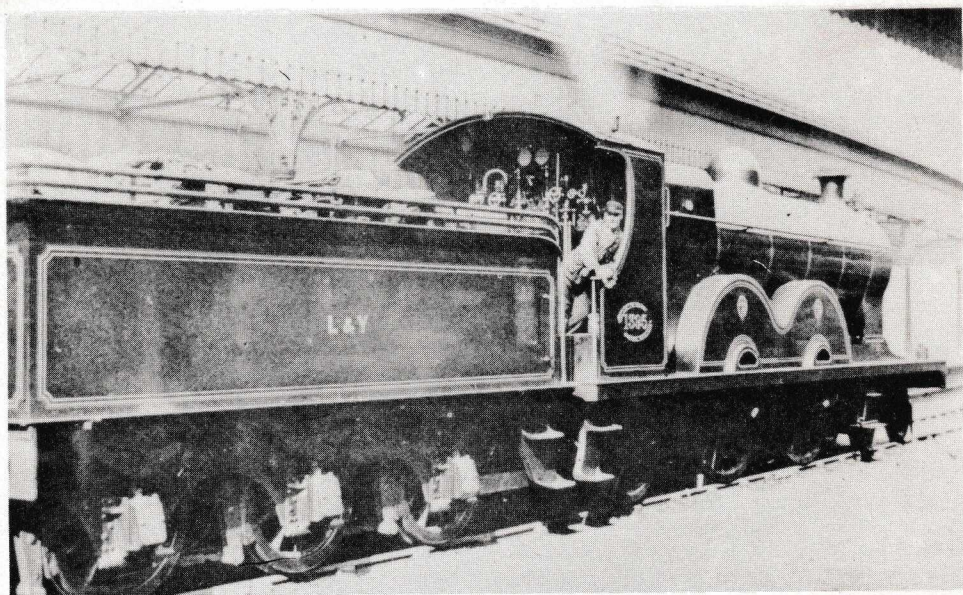
Cover Photo: Aspinall 4-4-2 No. 1395 in 1900. The low cut cabsides are clearly visible in this view which also shows the crank on the cab roof connecting the 'emergency cord' to the whistle. Notice also the shed plate in its slot on the edge of the cab roof, its No. 1 Newton Heath plate being clearly visible. The tender displays the L & Y used on tenders in the 90's and dropped in 1901 in favour of the full title of the railway. It is also obvious that the number plates were relocated higher on the cabsides when they were altered to conform with later built locos.

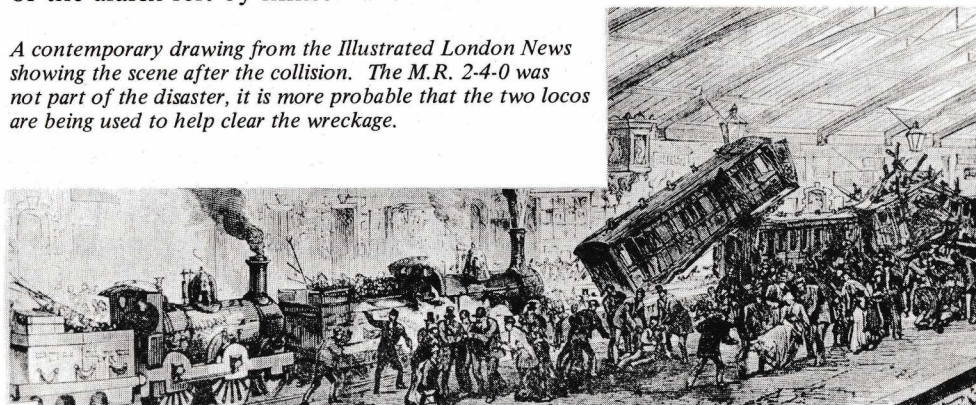
*A contemporary drawing from the Illustrated London News showing the scene after the collision. The M.R. 2-4-0 was not part of the disaster, it is more probable that the two locos are being used to help clear the wreckage.*

The 2.10 p.m. from Liverpool to Todmorden had arrived at Blackburn punctually at 3.05; the rear vehicle, a Midland composite carriage (*Engineering* has this as a Pullman car), was being detached by Jenkins 0-6-0 No. 682 'Vesuvius' (Works No. 187 b.9/1864 reb. as 0-6-2T 7/82, withdrawn 2/98) when the 2.25 p.m. express from Manchester to Hellifield, due at 3.14 ran into the shunting engine, (the *Illustrated London News* gives it as an Edinburgh/Glasgow train). The express consisted of Barton Wright 0-4-4T No. 74 (Dubs works 1156, b.10/1878, withdrawn 2/07) with 7 coaches—4 composite, 2 third class carriages and guard's van and was fitted with Westinghouse brakes. (*Engineering* quotes engine with tender and 7 coaches). As a result of the collision the two engines became interlocked, drove the carriage which was being shunted into the rear of the Liverpool train where a couple of carriages were telescoped and wrecked the second and third carriages of the Manchester express. Seven people were killed with nearly thirty injured.

The crux of the matter seems to have been the relationship between the driver and the Westinghouse brake. Stansfield said the brake had been working well when applied at Darwen but on applying the Westinghouse at Old Jct. the brake failed to grip. He had only three weeks' experience with Westinghouse brakes. The fireman of the shunting engine said that just after the express was coming under the roof of the station he saw the driver shut off steam, whistled for brakes and reversed his engine. The guard corroborated this but did not feel the Westinghouse brake put on, there being no rush of air, a proof that the brake was full on. He thought the express passed the West box at 30 m.p.h. and struck the shunting engine at 20 m.p.h.

It seems that when the signals were off it was the practice to apply the Westinghouse brake near West Box, 172 yards from the point of collision. A train composed exactly like the express was made up for trials. It was found that with a speed of 40 m.p.h., the estimated speed of the express passing West Box, when the Westinghouse brake was applied the train was pulled up in 231 yards, or 59 yards further than the point of collision.

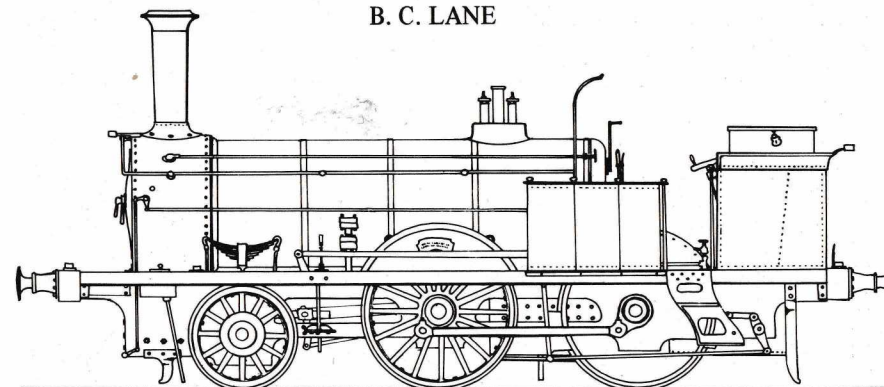
It was in 1868 that the first of the 2-4-0 Well Tanks appeared from Miles Platting Works to the design of Yates. They were extremely neat little tank locomotives and compared well with what other railways were building in the mid-Victorian period. No.32 displayed the new 'straight-back' boiler which was to be the standard until Barton-Wright introduced domes again. The locos of Jenkins had used a raised fire-box and a very large copper dome, so the new boiler must have been a strange sight to the men of the day. As built, the engines were well tanks without cabs. Ahrons writes that the engines were "miserable little undersized machines" (1) but when this is seen through his eyes, the statement is understandable. Ahrons lived in Bradford at the time the locos were new and the fact that 12 of the class of 25 were sent to the West Riding where he would witness them struggling up the gradients is possibly why he said that about them. They must have lacked adhesive weight, so necessary at Bradford where trains had to start up a 1 in 50 gradient in a very damp tunnel. No doubt others of the class which worked in the Southport and Blackpool areas managed a little better. Five locos were sent to the East Lancashire Railway to replace withdrawn 2-4-0s and they were allocated the same names and numbers. In their original state the nameplates were fixed to the splashers though 'Sunbeam' and possibly others had the nameplate on the saddletank when rebuilt (2).

It is generally supposed that the last of the class which was built in 1874 was built with saddletank and cab (3). With the cramped conditions at Miles Platting and the serious fire in 1873 it had taken the railway seven years to build the 25 locos. Barton-Wright was appointed in 1875 and all the class were rebuilt with saddletanks and cabs from 1876 although it was December 1881 before all the class were treated. The new numberplates were fitted at this time and on the Author's model of No.18 plates

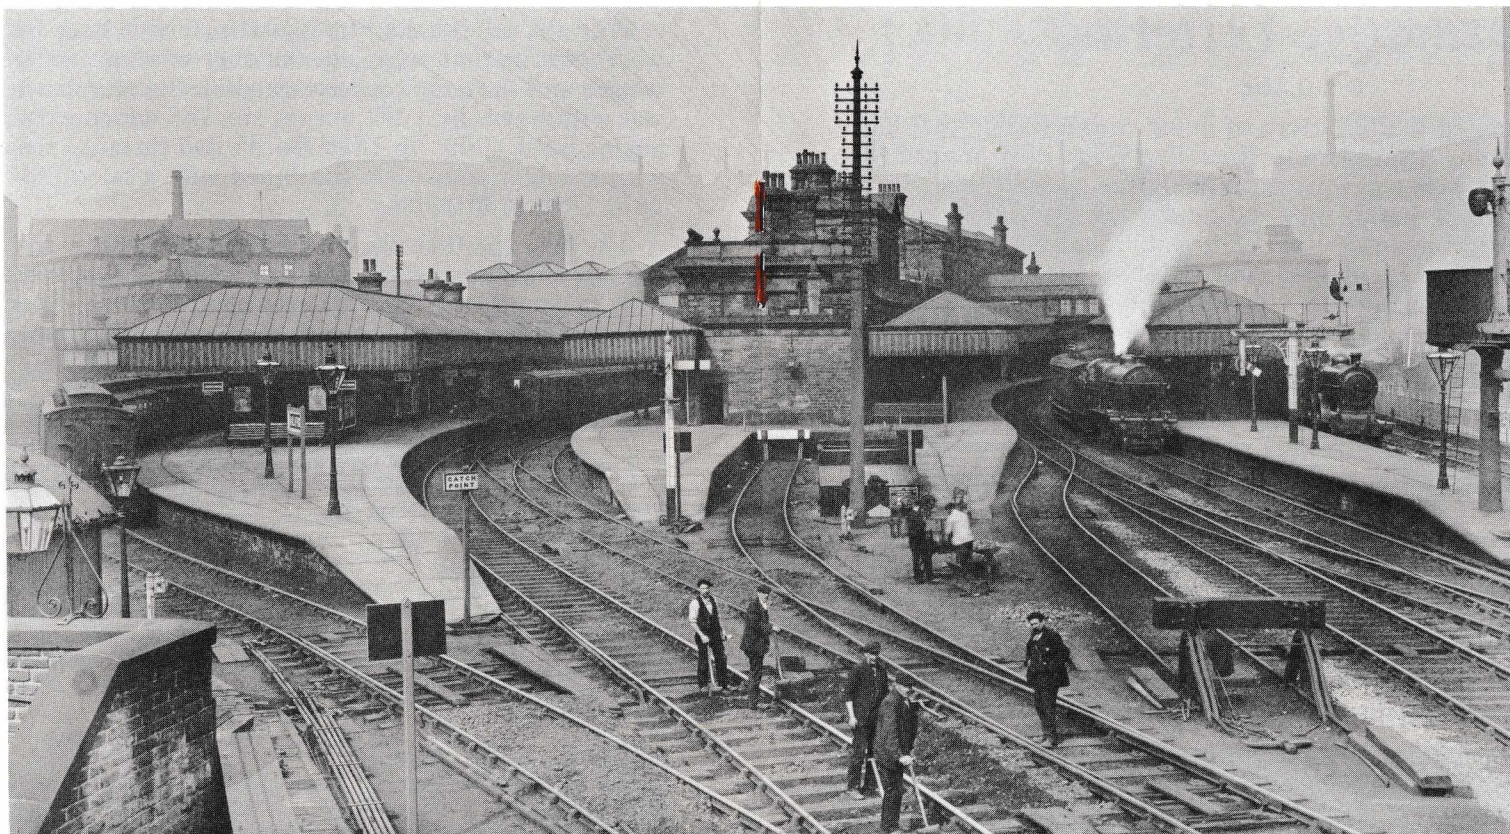
## HALIFAX 1912

*The photograph was taken on the 30th August 1912 and I have concluded that the picture must have been taken about 1.30 p.m.*

*The platforms were numbered 1 to 4 from right to left in those days, each platform having two sides to the one number. The train indicator on the platform showed which side was being used for each destination.*

*Platform 2, the main L & Y departure platform for Bradford and Leeds would, if we have got our time correct, have dealt with the Liverpool to Leeds train leaving at 1.17 and the Stainland rail motor arrival at 1.20. The stopping train to Bradford, due away at 1.25 would have left very shortly before the picture was taken.*

*Platform 3 had little traffic excepting G.N. arrivals. One was due at 1.30 at the time we are thinking of, and would, I anticipate, arrive very soon after the picture was taken—what a pity it was not there to show a G.N. as well as L and Y and North Eastern trains.*

*Finally we come to the inner side of Platform 4 where an L & Y set is standing, probably the Huddersfield train due to arrive at 12.43. If I remember rightly this train did not come to Platform 2—I was very frequently at the Station at that time as I left by the Stainland rail motor every Wednesday and Saturday at 12.44 for many years.*

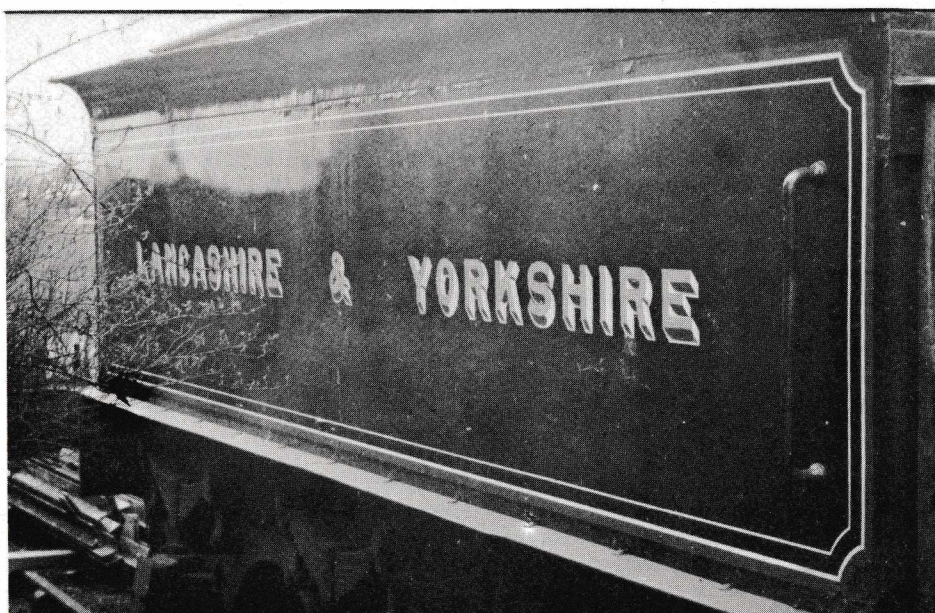
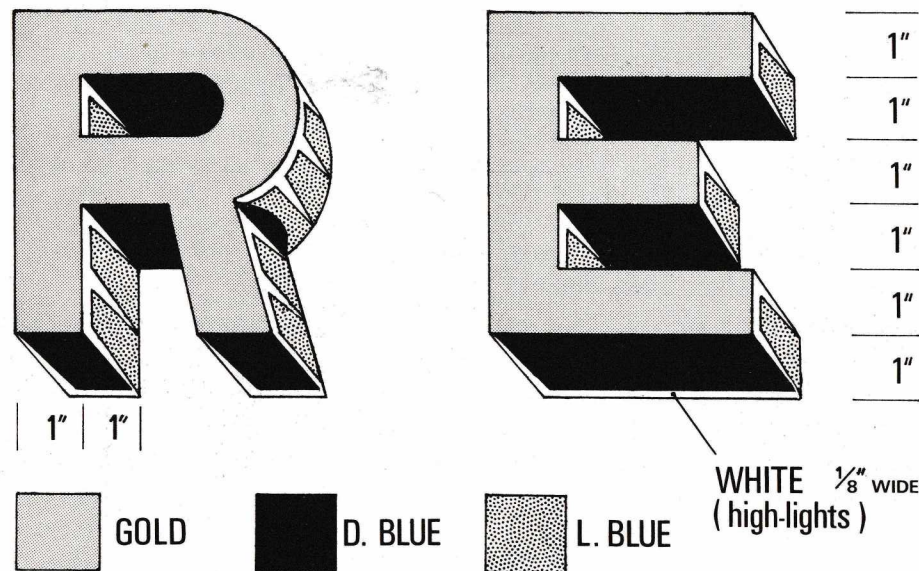
LANCASHIRE & YORKSHIRE

It was Hoy who originated the full livery of lining with lettering that has become so familiar to us. Although the 'final' livery was only applied to locos for twenty years, those years were probably the railway's finest when it became well known for its efficiency and modern developments. The loco livery which Aspinall had standardised had no identification on it save for small initials on the tender engines. Hoy added to the existing lining the full lettering of tanks and tenders. 'A' Class 0-6-0 No. 1139 was the first loco to be lettered in January 1901 and tank locos began to be lettered in February the following year, 1902. All passenger locos were lettered, the division lying in the Barton Wright 0-6-0 'Dreadnoughts', of which only those which were fitted with train heating gear were lettered and the 0-6-2 tank locos of which the 5'-1" locos were all lettered but only a few of the 4'-6" locos were treated. In the beginning Hoy arched the letters on tank engine sides in a large arc a little over 15 feet in radius. Hughes changed the lettering to a straight line in 1904 but it was many years before the arc style disappeared completely. Tenders did not change much through the twenty years. The smooth sided tenders had the lettering positioned centrally on the sides but the older tenders with snap-head rivets had to have the letters applied above the centre line to avoid the rivets. On the standard six wheeled tender the combined 'Lancashire & Yorkshire' lettering was 160 inches in overall length. On the eight-wheeled tenders the letters

were the same size but were spaced out more in order to fill out the side. The '&' was used on the arched style of lettering on tanks but was left out in the straight style, the number plate being placed centrally between the two counties.

All the letters were 6" in overall height including the shadow. The letters were gold leaf and the shadow was pale cornflower blue to the right and deep blue below. The letters were highlighted in white. If you are modelling in 4mm scale, the small sheets of gold instant lettering by Blick (BOE 59) are almost perfect for the letters although the blue shading will have to be added by hand. In such a small scale it is probably as well to forget the white highlights. If you have built a 0-6-0 saddle tank or 0-8-0 you should line your loco in red only, similar to the cover of the Hundredth Newsletter and not the red and white 'passenger' livery. If you have built a 0-8-0 with the side windowed cab it is incorrect to letter your tender although it could be lined, as No. 1427 was the first loco to be rebuilt with this cab in 1923 and the lettering was dropped from the livery when the L.Y.R. merged with the L.N.W.R. in 1922. Some locos were turned out without lettering in the Great War presumably for economy.

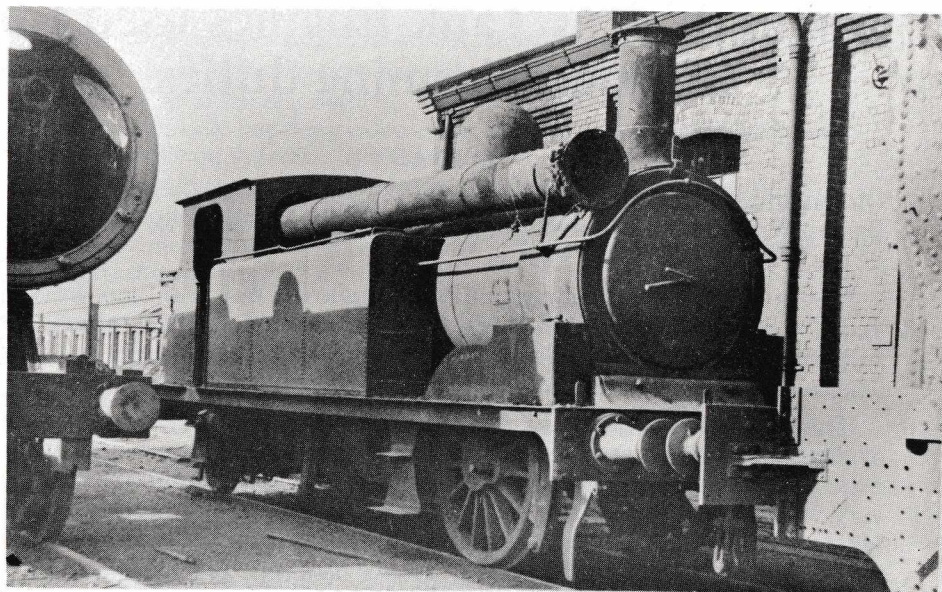
Ex 0-6-2T at Horwich in September 1932.

0-6-2T (5'-1") September 1932 — condition 'Good'

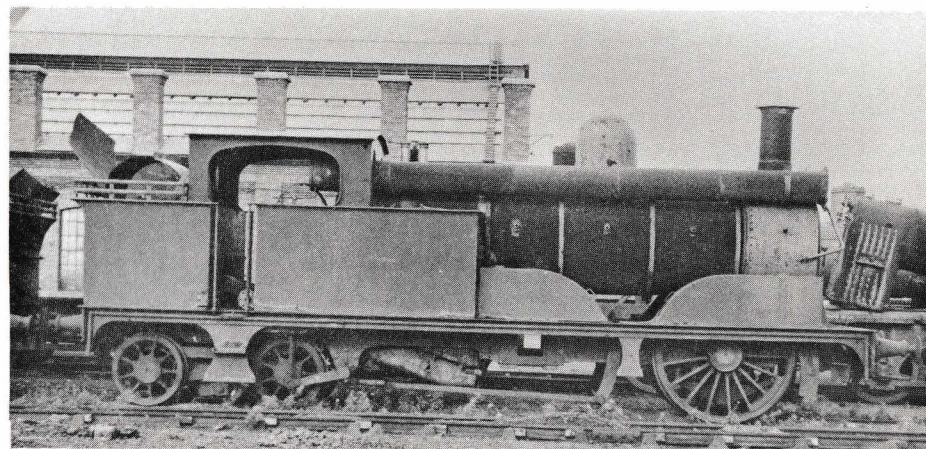
Ex 0-4-4T in the 30's referred to in the text.

0-4-4T Taken in 30's — condition 'Rough' — possibly in for scrapping.

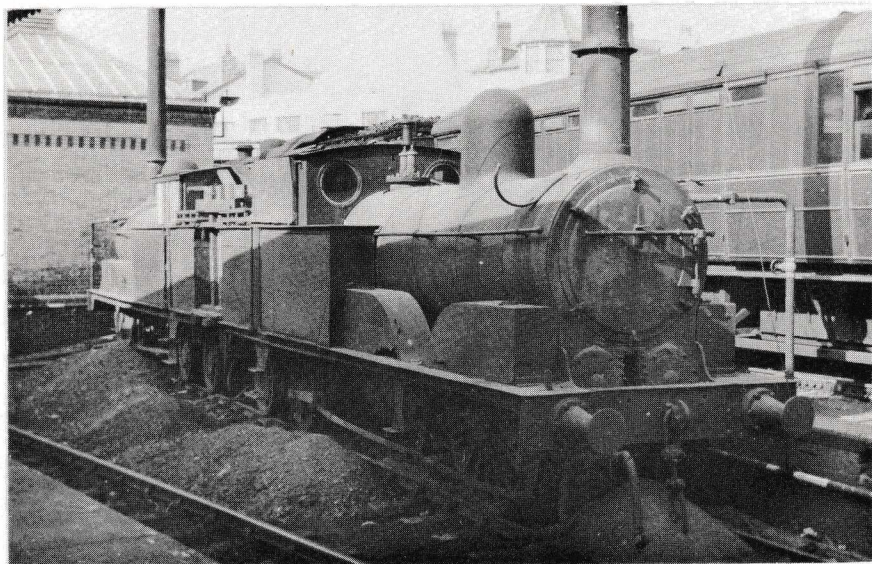
The 0-4-4T's had the 2nd or driving axle and all motion removed, whilst the boilers had all regulator gear removed—simply having one gauge glass, pressure gauge, injector and carriage heating valve left in position. Only the hand brake was left in. Generally they were 'choked' once in position. The 0-6-2T's also had the 2nd or driving axle and all motion removed, one (at least) retained the third axle with the brake working on this only.

The two tanks at Blackpool Central were personally identified by me after being told that the piston slide bars (still in position) always carried the loco numbers. Filthy but successful I emerged with the numbers 910 and 480; this identifies another two locos anyway.
