PLATFORM 26

THE JOURNAL
OF THE
**Lancashire & Yorkshire
Railway Society**

Platform 26 is the Summer 1988 edition of the Lancashire & Yorkshire Railway Society Journal. Up to four editions of the journal are published each year with six illustrated Newsletters at regular intervals. For further details of the Society, please contact the Honorary Secretary, Mr Tom Wray, 17 Chale Drive, Manchester M24 2BZ.

Attock's 4-Wheel Break Vans The Prequel

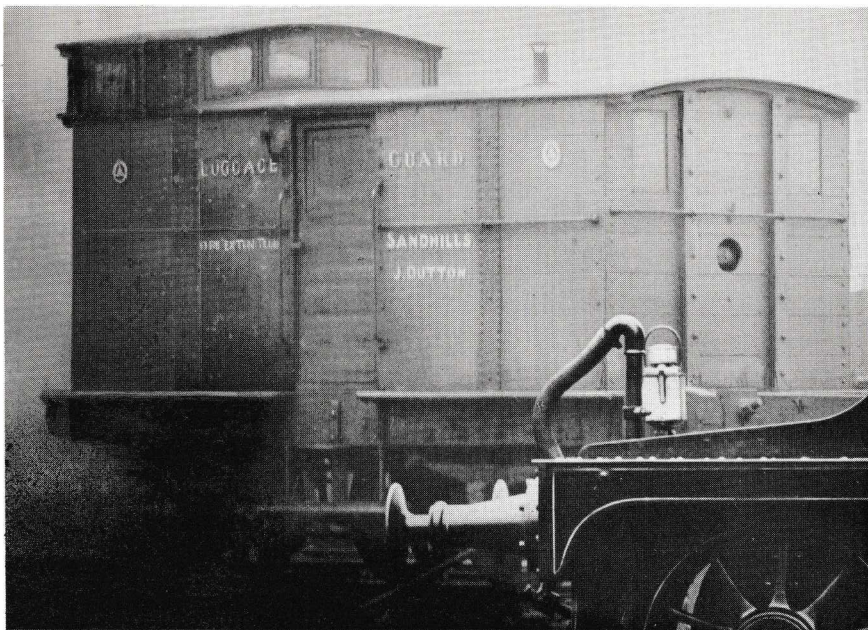
Comparison of this view of a Birdcage Break with the official drawing shows many differences. The steps and handrail are not fitted to the end, the 'Maltese cross'-type brake hanger is bolted behind the solebars, the lamp bracket is on the left of the door and the door plank-ing is narrower than planned giving four and a half planks instead of three. The location is Sandhills shed and the loco is 6 ft. 4-4-0 No. 831.

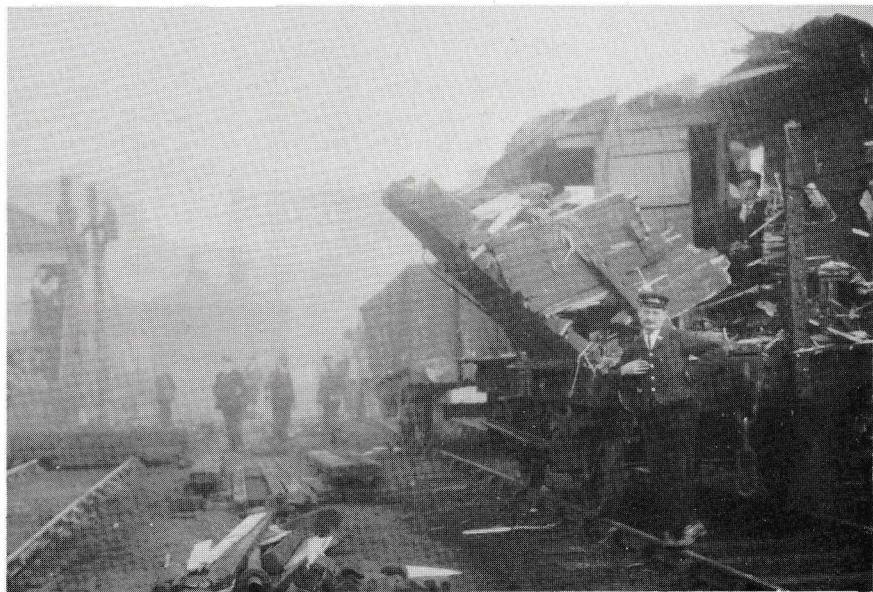
The end of a break van in a smash at Lockwood 28th October 1913. The vehicle is an early type with the cross-shaped break hanger but has tie rods to brace the 'W' irons of the under-frame a feature not seen elsewhere. All other details agree with Drg. 2309 of 1890.

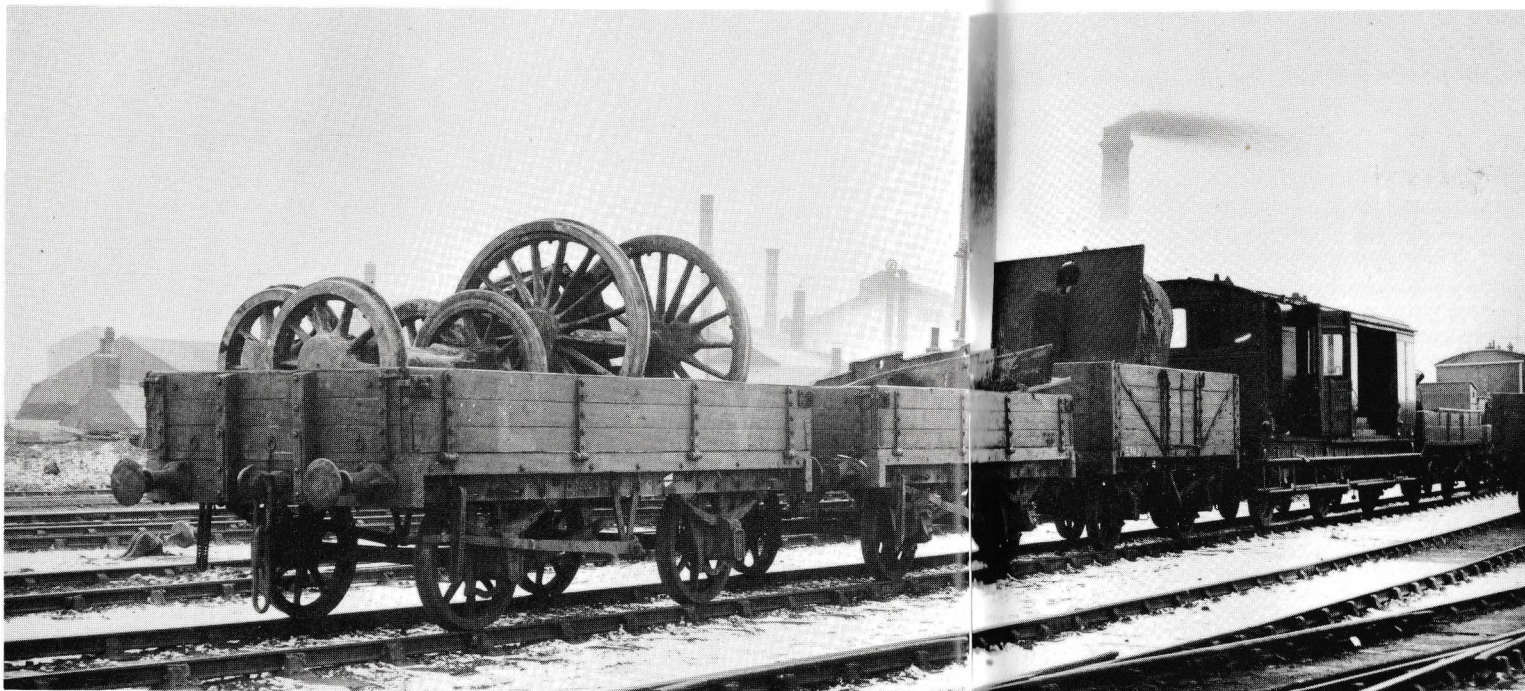
The wagons contain manageable pieces of the cut-up locomotive. The nearest wagon carries the two sets of carrying-wheels and the rear drivers while the second wagon has the left-hand water tanks. Both wagons are 3-plank dropside 10-ton types to Diagram 15 (numbers 7300 and 24641 respectively). The third wagon contains the firebox and part of the bunker water tank. This is a Diagram 16A 5-plank wagon which was a development from the earlier but similar 4-plank type built to Diagram 16. The tool van of the breakdown train stands in the background. Photograph taken 22 February 1916 at Penistone.
