PLATFORM 29

THE JOURNAL
OF THE
**Lancashire & Yorkshire
Railway Society**

WORKING WITH THE BURY ELECTRICS ..	1
CLIFTON JUNCTION POWER STATION	5
ELECTRIC LOCO No.2	11
VICTORIA EASTBOUND BAYS 1910	14
DIAGRAM 50, 20T STEEL HOPPERS	16
ELECTRIC LINES RULE BOOK	20
SHORT-CIRCUITING BAR	21
ALTERCATION AT PENISTONE	22
LYR 'FAMILY TREE'	26
HOLME OR HARE?	28

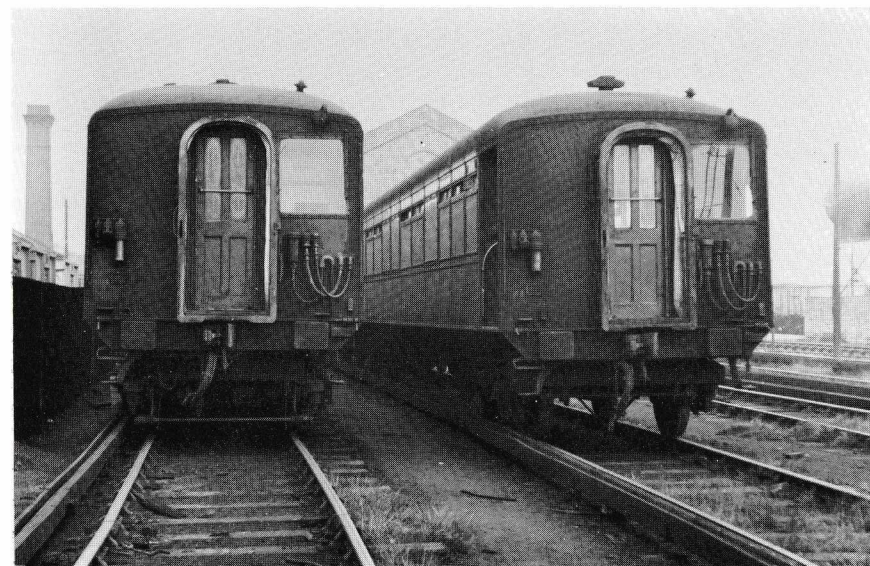
Motor coach 28535 and trailer 28708 outside Bury carriage shops in September 1958.

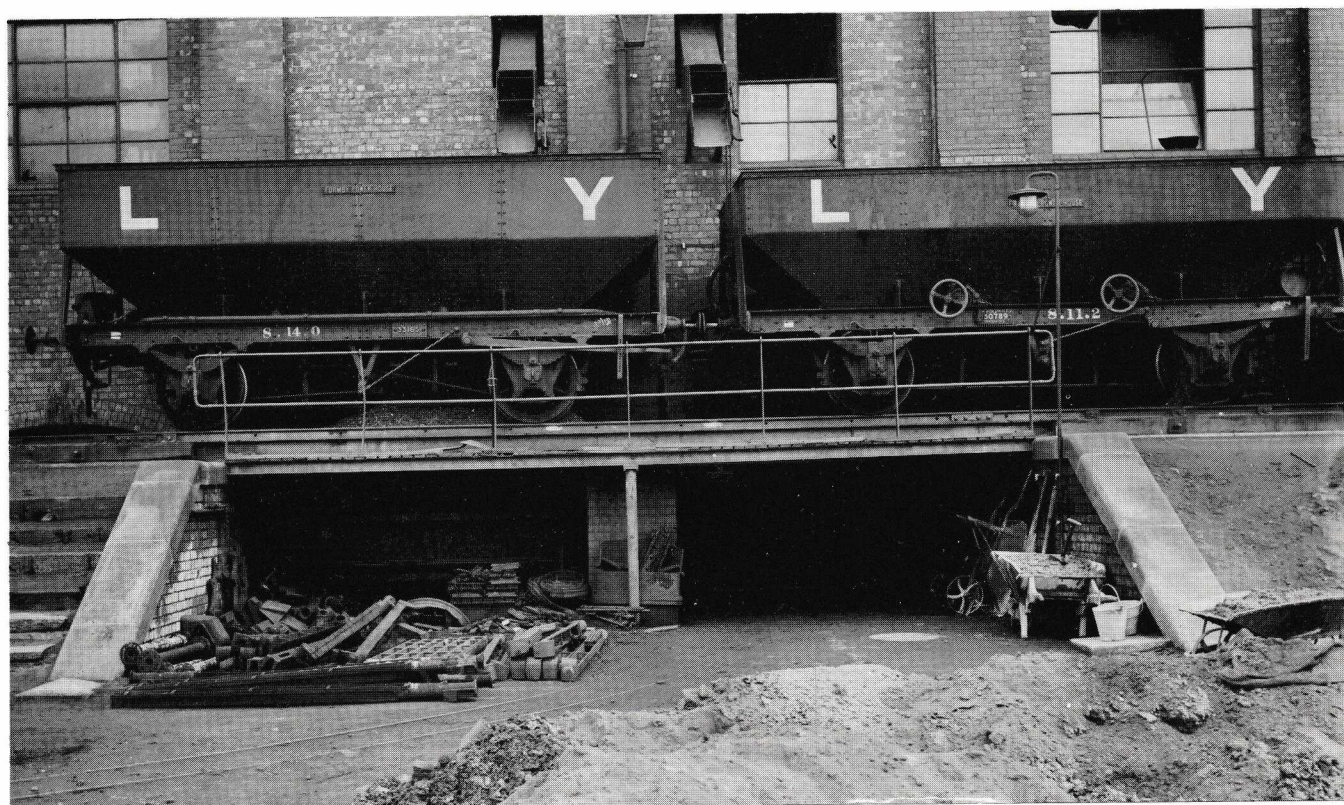
Wagons 33165 and 30789 on the ash siding at Formby about 1910. The two different body sizes are immediately apparent. Not so obvious are the alternative positions of the vacuum hose between the earlier and later vehicles. Note too how the vacuum piping is taken around the frame on the opposite side to the hopper door handwheels. In the foreground is some 18" gauge trackwork similar to the Horwich and Newton Heath systems . . . the latter like Formby being manually operated.
