PLATFORM 13

Platform 13 in the January 1984 edition of the Lancashire & Yorkshire Railway Society Journal which is published three times a year with the occasional similar booklet on L.& Y. branchlines. Members also receive a regular newsletter and meet monthly in members' homes. For further details of the Society, please contact the Editor at the address below.

CONTENTS

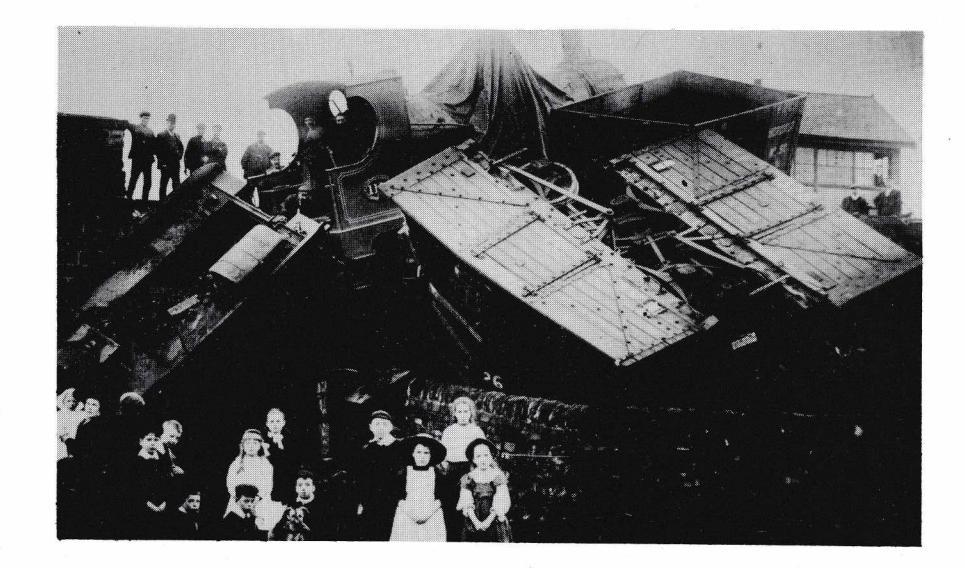
If ever there was an unlucky place on the L. \Im Y.R., it must be the bridge at Mirfield shown in this pile-up. In March 1895, a DX 0-6-0 fell into the roadway (see p.58, John Marshall's LYR Picture History) and in January 1922, an 0-8-0 did a very similar trick (as illustrated in LYR Miscellany, plate 262). Although both the above mention each other, this contretemp with an 'A' class and some local coal wagons has gone unrecorded. It is impossible to identify the locomotive exactly as only the first two digits of the number are visible. The tender is of the Aspinall pattern and these were only fitted to Nos. 1180 to 1199 so it narrows the field down somewhat as all others in the 11xx series were paired with old Barton Wright tenders from his 0-6-0s rebuilt into saddle tanks. It can only be coincidence that the series from which this particular loco came from were Lot 13!

Presumably, no one was hurt and the engine appears to have sustained the worst damage.... from the wagons hitting it as they followed the route from rail to road. The hand rails have been torn off and the sheet over the dome suggests further damage.

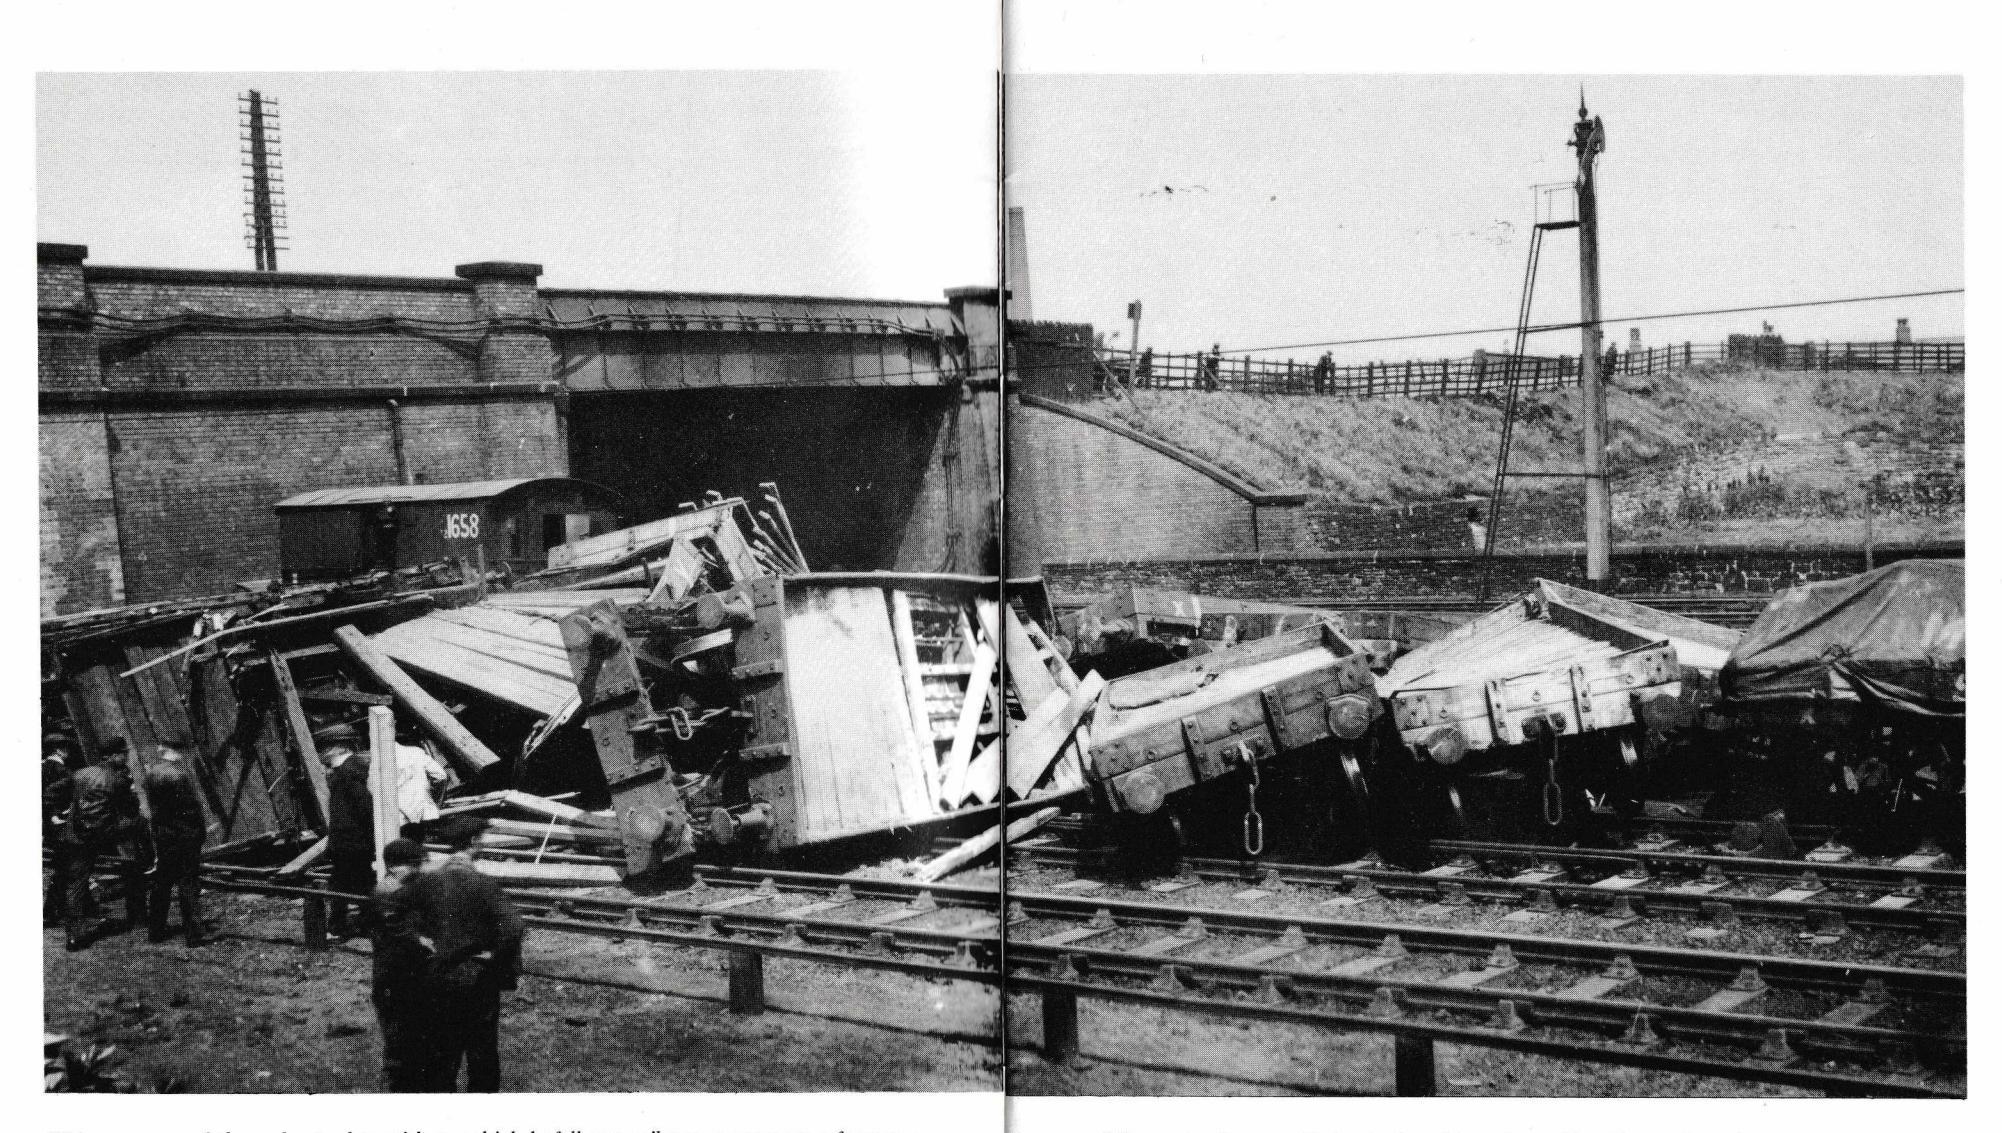
This was one of those day-to-day mishaps which befell any railway—a runaway of wagons ending in a mangled heap with no-one hurt, a lot of clearing up to be done and delays to services which ensured that those 'on high' got the clearing up done super quickly (though six men are watching and only one possibly working). The photographer in this case was Eric Mason, the location is Agecroft Junction and this is one of the pile-ups he termed 'a gas meter special'—indeed the picture is a companion to the top plate opposite p.64 in "My Life with Locomotives" and, for my money, a far better illustration.

For the wagon aficionado there is considerable interest, for everything that has come to grief is $L \otimes Y$, mostly single plank opens from Diagrams 73 and 80, the 12' and 10'-6" varieties respectively. Some display of wagon building techniques is on view with the odd underframe poking out of the debris. How curious it is to see so many floor planks have fallen out or been pushed out of position. A considerable number of wagon ends are on view with buffing and drawgear made much easier to inspect than in official three-quarter views of rolling stock. The original photograph clearly shows different styles of packing, or not packing, buffers to similar vehicles and one repair consists of a crude rectangle of wood. Alternative headstock styles are identifiable too. Different wagons show various paint colours, probably attributable to the slightly different paint mixes concocted in the paint shop, and to varying amounts of weathering over time out on the line. Finally, and probably most interestingly, there is a Tin Tab in the background, No. 21658, which has some additional transverse metal strips which appear to be bolted through a very thin roof, could this be metal as well? Another problem to be solved.

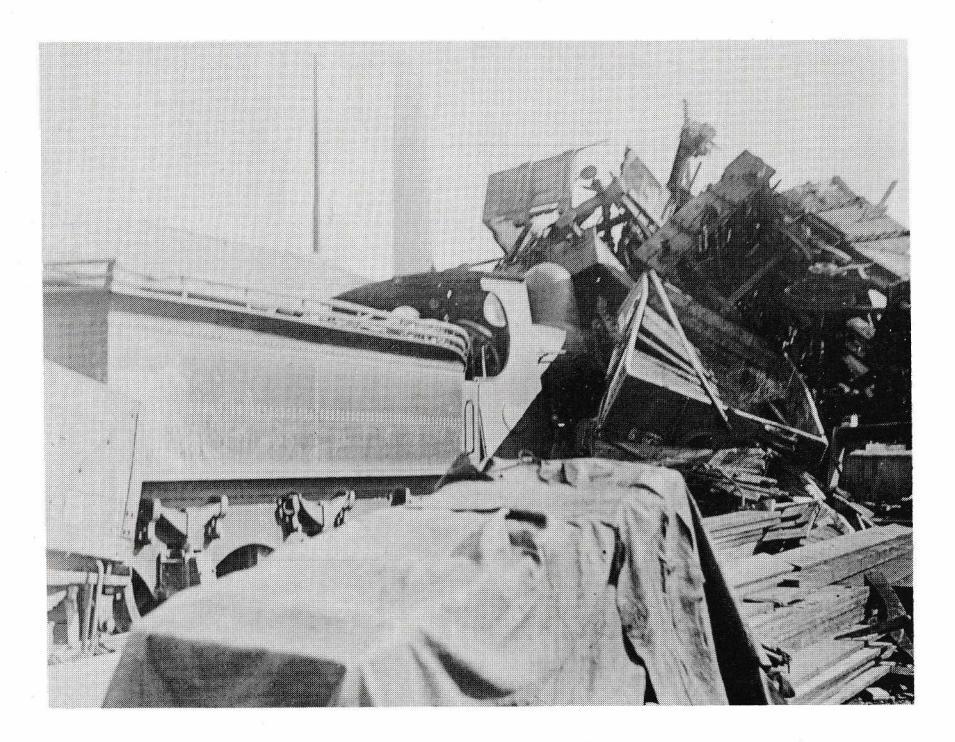
The 9.10 p.m. fast goods from Earby to Salford was descending Baxenden incline just south of Baxenden Station early on 16th August 1923, when Aspinall 0-6-0 No.444 got out of control. A commendably watchful signalman diverted the train into a reception loop at Stubbins Junction where it collided with wagons in Ramsbottom goods yard, destroyed several offices and finally came to rest in a goods warehouse. There were 57 loaded wagons in the train, totalling 610 tons. It had been banked up the incline from Accrington Station by 0-8-2T No.1501, which was later blamed for pushing the train too far over the summit for wagon brakes to be pinned down. Eric Mason took the photos on the 17th when he arrived with the breakdown crew to tidy up.

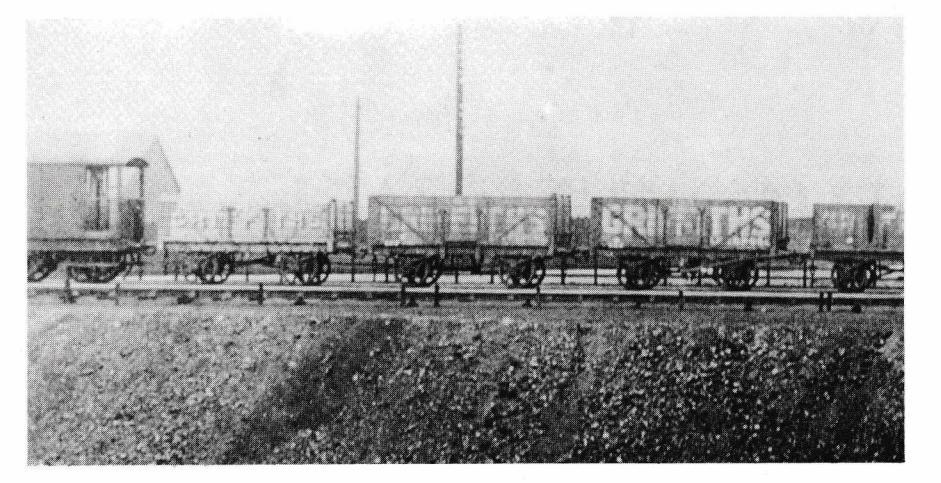
The company legend 'GRIFFITHS' was split evenly into three letters per box thus 'GRI FFI THS', with the word 'Liverpool' on the bottom plank of the right hand box. The same applied on the other side. Closer examination of the photograph reveals that the right hand box on the wagon has been placed onto the wagon base the wrong way round thus producing the legend 'GRI FFI GRI' and is the first recorded instance the writer has come across of this occurring. What a casual onlooker would have made of the legend appearing on the opposite

side of the wagon is intriguing. Details of the company legend on the other two 3-Box wagons are indecipherable, but what is of interest is the mode of construction of all these wagons.

The first two (from right to left) appear to rest on a wagon base which seems to have a shallow single plank along the sides and ends, within which the boxes are placed. No 'separation pieces' are visible between the boxes and there seem to be no vertical retaining end pieces as was sometimes the case. Other than this, the wagons follow the general pattern for the type.

The third, slightly larger 3-Box wagon does not display a single plank feature as described above, although it conforms otherwise to the general outline of the type. However, one curious feature is just discernable on closer examination, namely the two broadly separate vertical markings resembling strapping which is on the sides of each of the boxes as they appear on the wagon. To the writer, these appear to be hinge straps, not merely re-inforcing straps, perhaps providing evidence of a different mode of opening the bottom doors. Better evidence than this is needed to confirm that view.

All three wagons have evidence of a numbering on the top plank of the centre box, the initial number of which appears in all instances to be '7--'. If this reading is correct, we may be looking at three of the 3-Box Coal Wagons 'rebuilt' for Griffiths in 1909 by the Wigan Wagon Company, although whether this was a rebuild of original 3-Box wagons or of old standard 'half-box' wagons is not clear from the registers. However, evidence of any clearly definable legend on the two of the box wagons makes firm assertion on their origin mere speculation.

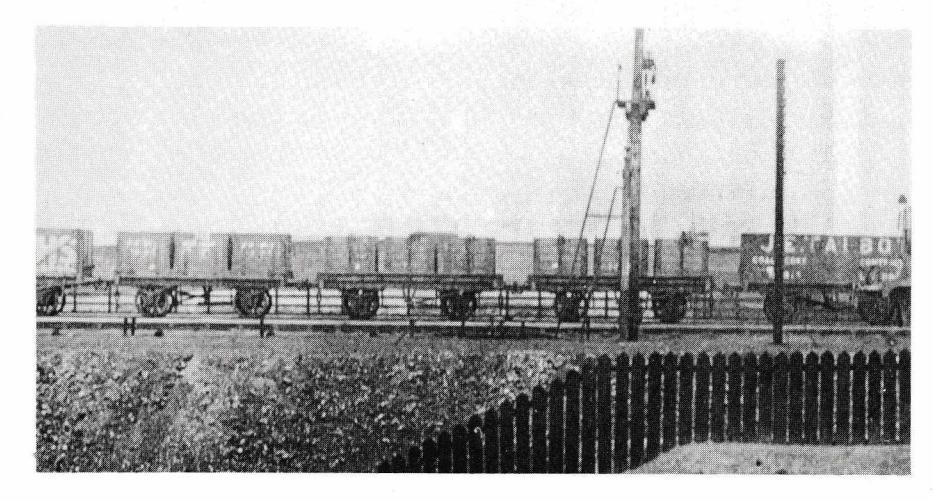
The two wagons immediately following the 3-Box wagons are virtually similar in size, the first one being a 6-plank vehicle, the second a 5-plank one with broader planking. Both are 10-ton vehicles. The wagon next to the break van is a much older 8-ton wagon with corner strapping clearly in evidence on the fixed end. The lettering shows interesting variation in that each succeeding wagon has smaller lettering than the one before.

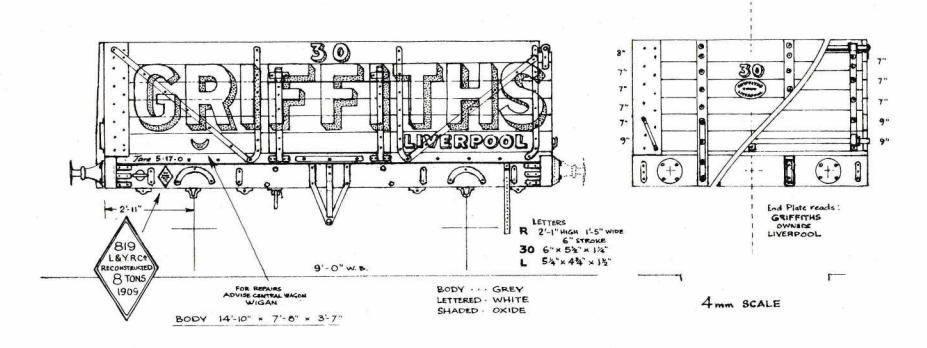
Reproduced appropriately below are authentic details of the livery and lettering of a Griffiths wagon from a drawing which is in the writer's possession. This shows an 8-ton vehicle rebuilt by Wigan Wagon Company in 1909, together with full details of plank sizes, dimensions of the lettering and incidental features.

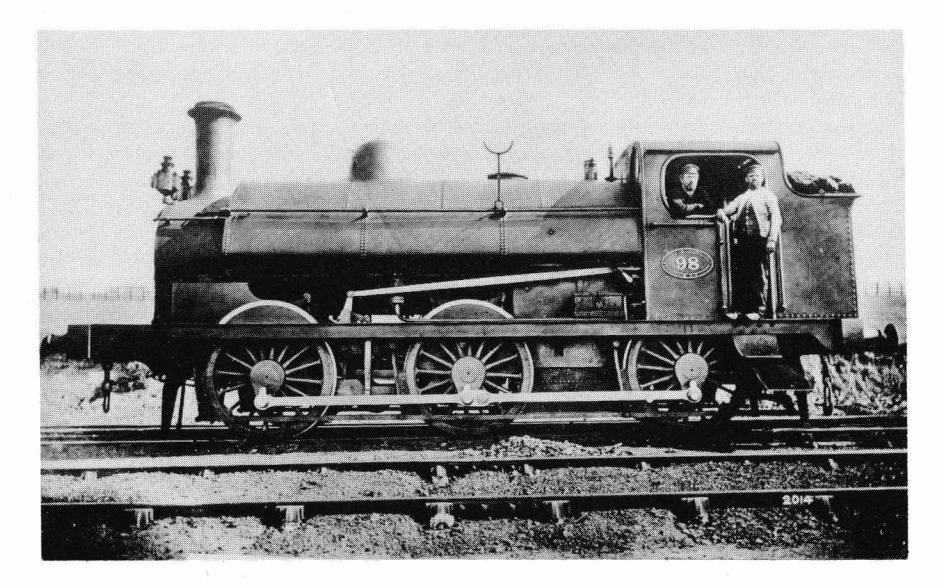
The likeness to the later Aspinall rebuildings is very clear in this view of No.98. The staff are rightly proud of their engine which has the brass beading over the splashers polished brightly. The overall black livery of the period was unofficially relieved by the personal efforts of the staff. The brake blocks are of wood which was probably adequate for shunting duties. In 1891, Aspinall started rebuilding the 'Ironclads' to saddletanks which would contribute to the demise of this class, for No. 98 was scrapped in 1896 after only 19 years service.

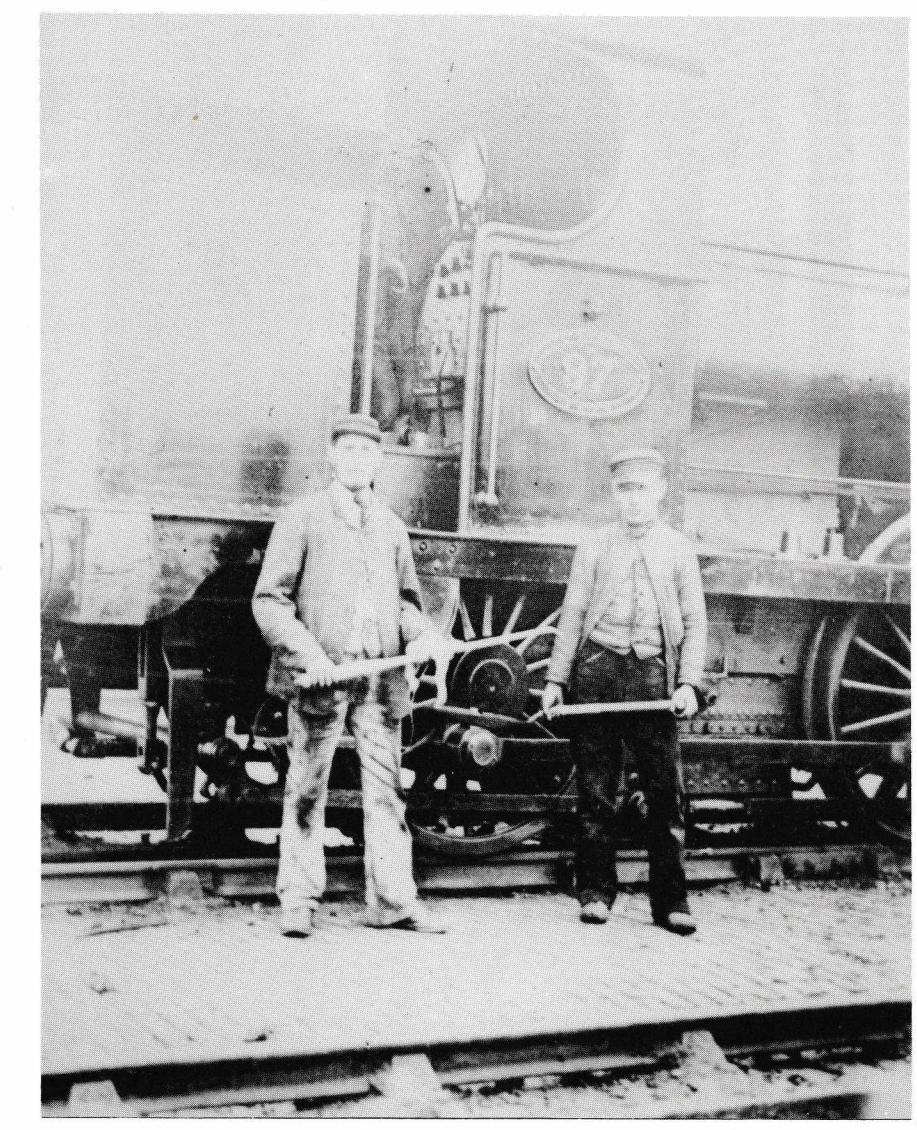
No.97 was withdrawn in April 1895, making this view of the crew and details of the engine all the more interesting. The driver is holding a long necked oil can which was so necessary on locos with inside motion and a familiar part of the engineman's kit in the old days. The red lining is just visible on the bunker side. At this period, only the new passenger locomotives of Aspinall's designs carried the white and red lining and because of the orthochromatic photographic emulsion of the time being 'blind' to red pigments, locomotives usually appear to be plain black.

The above illustration is one of a few known to have been taken by the Reverend W. A. Wickham in the Wigan area about ninety years ago. Most of his photographs feature canals, mines and churches so this study of railwaymen backed by their machine is of particular interest. Notice the sockets for the old style of lamp, on the firebox valance. The lamps sat in the socket and of course could not stand upright without such a cavity to rest in . . . these being for spare lamps not in use at the time. A change to the bracket-mounted type of lamp took place after the turn of the century but these locomotives appear to have all missed the new fittings.

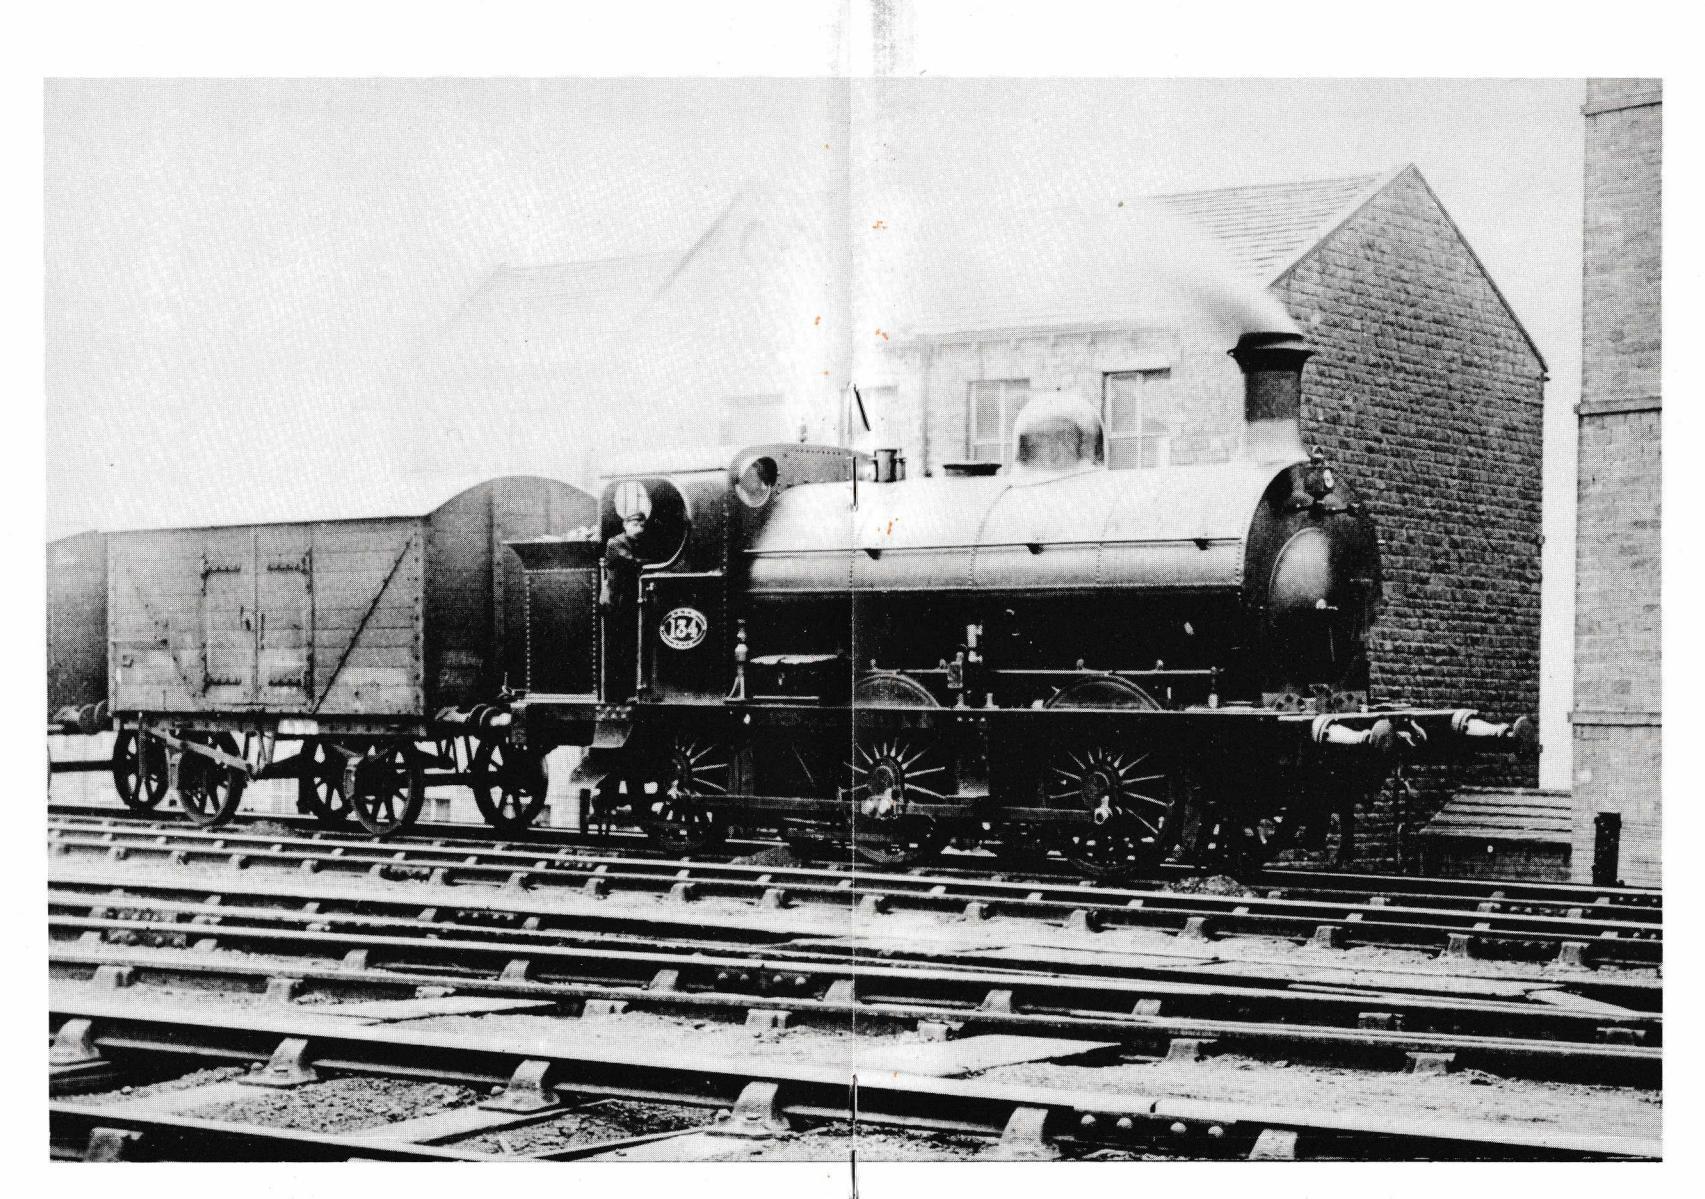
The products of Miles Platting works were short-lived and No. 134 was one of the last to remain in revenue service. Seventeen of the class of useful shunting engines lasted into this century, when the rebuilding of Barton Wright's 'Ironclads' had stopped but only four were still extant when George Hughes took charge of the locomotive department. No. 134 was the last one in service and the last loco to carry the Yates style of cab that was once so common on the L. \mathfrak{S} Y. As shunting engines they were probably quite the master of such insignificant work. The lampsockets were never altered from the Victorian type and once again they were probably the last on the line to carry the old code. The vehicles behind the engine are the common Diagram 3 van with one-sided brakes and the lever on the other side (as viewed here) being toward the left end, is mounted on the same cross shaft. The number 18174 is just visible on the end but no identification of ownership is to be seen on the side. The date of the photograph could be anytime since 1876 when the engine was built except that the cast brake blocks suggest the turn of the century. They might well have contributed to the longevity of this particular engine. The stone-built and roofed buildings suggest Yorkshire as the location.

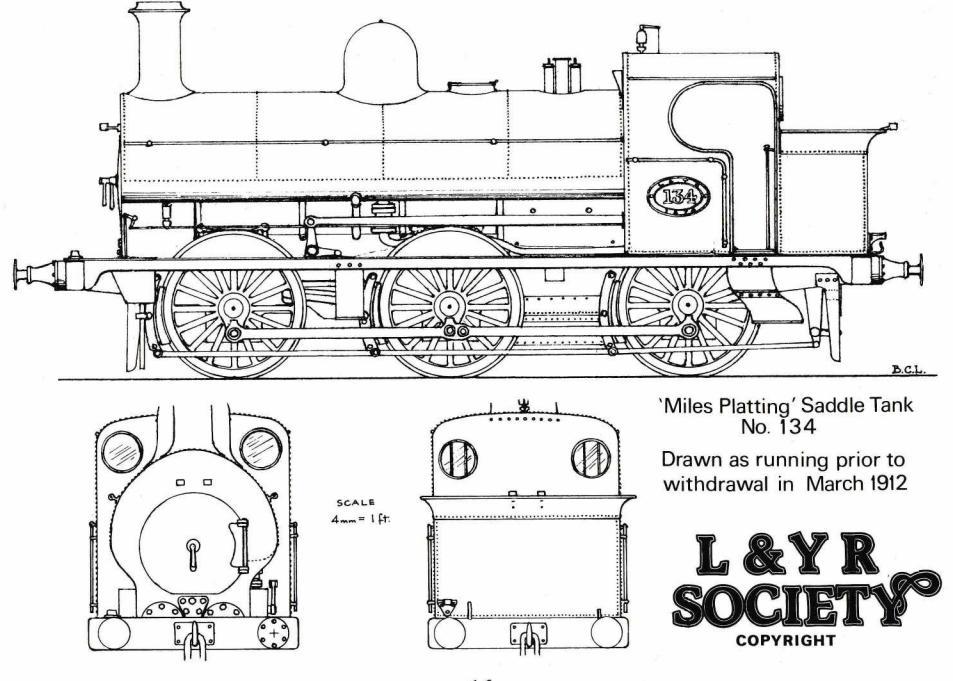
No. 134 was one of the earliest built and yet was the last to be withdrawn in 1912. Like others in the first series, they had tanks that extended to the front of the smokebox and flared top bunkers. The driving wheels were 4'-6'' but others were built with larger or smaller wheels. They formed a most useful addition to the loco stud of the day.

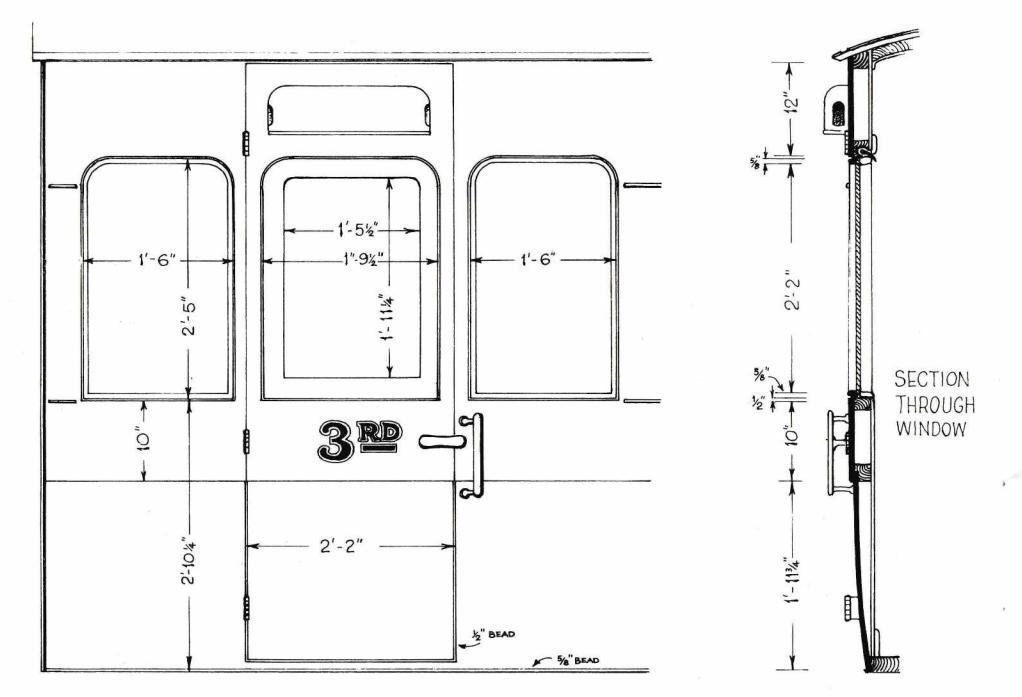
First of all, the L. & Y. was a great user of standard sizes and probably because Attock held the C. & W. superintendency for so long, these standards lasted longer than happened on other railways whose C. & W. post changed often. On the standard designs that we are considering, all doors to compartments were 2'-2" regardless of class. Doors to the guards van and luggage compartment were 2'-0" wide. All windows in doors, quarter-lights and toilets were square cornered at the bottom but curved at the top corners, the radius being 4". Below are illustrated the standard sizes of these windows.

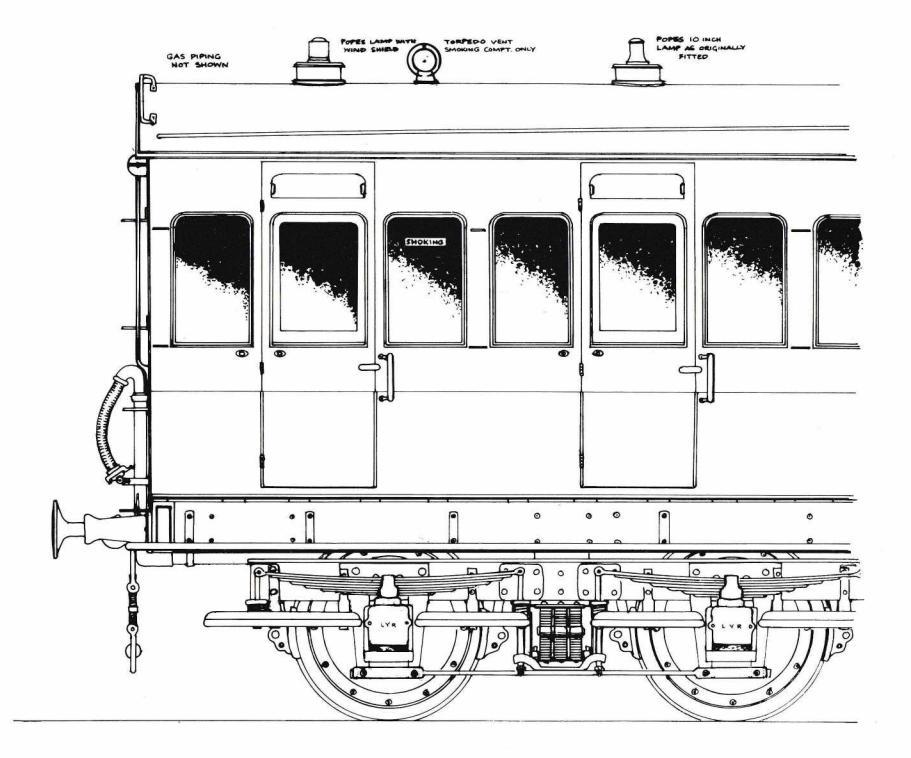
THIRD CLASS ELEVATION

The bogie is the 6'-6" wheelbase, transverse and lateral spring type fitted to Attocks stock in the majority of designs. The very similar 8'-0" wheelbase type was used on the earliest bogie carriages to shorten the gap between the bogies, which was longer than the point locking bars in use at that time. Although they became spread around all the various diagrams after refits at Newton Heath, the shorter type were the 'standard' size used on even the longest carriages of Attocks design.

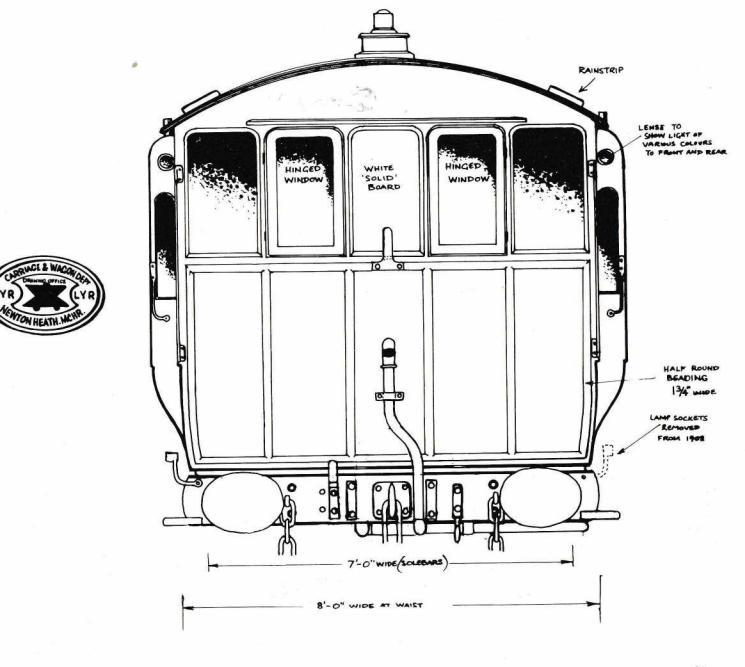
END VIEW-BRAKE END

A guards van/compartment carriage was different as the end steps to the roof were all at the one end, away from the brake-van-end windows. Steps were arranged in an inverted 'V' so that access was available from either side. Lights and emergency indicator gear was also at this end. The 'brake' end was arranged with the standard sized six panels below the windows but later designs had just five panels which matched the window arrangement of five apertures. The centre 'window' panel was a revolving board which was white on one side and that was shown in daylight hours. The other side was red and a red lamp was hung in front of it at night. The adjacent windows were both hinged in normal window fashion while the end windows were fixed. The long straight handrail below the windows was curved outwards in the centre on six-wheel vehicles. Bogie carriages didn't perpetuate this end rail but otherwise the ends remained almost the same.

Re-drawn from Newton Heath drawing No. 3011 of 1894.

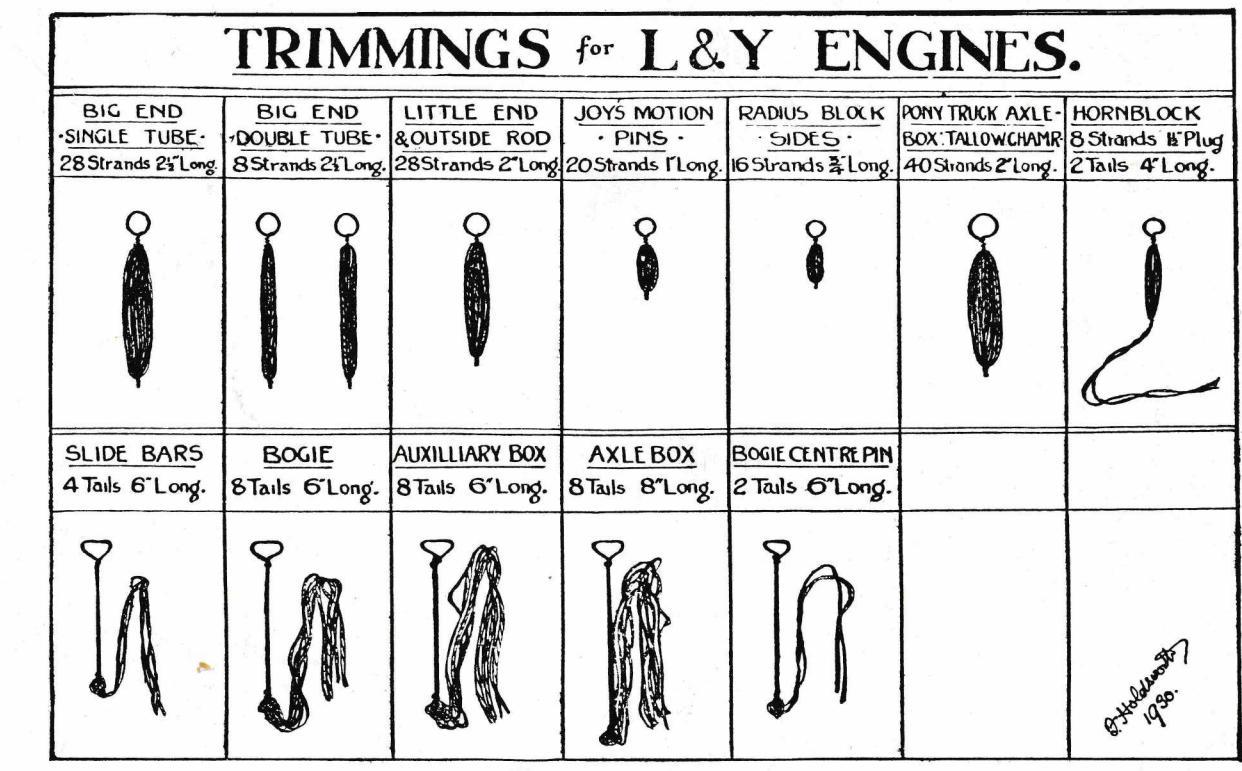
Not so much seasonal decorations, even if appropriate at this time of year. The L.M.S. produced this diagram in 1930 for the benefit of 'foreign' sheds with an allocation of ex-L, & Y.R. locomotives.
